**Flood Control Project Maintenance  
Levee Inspections**  
**LMA District Cover Sheet**  
**Spring 2018 Levee Inspection Results**

**Reclamation District No. 2064 River Junction**

**Levee Inspection Report By Mile - Spring 2018**

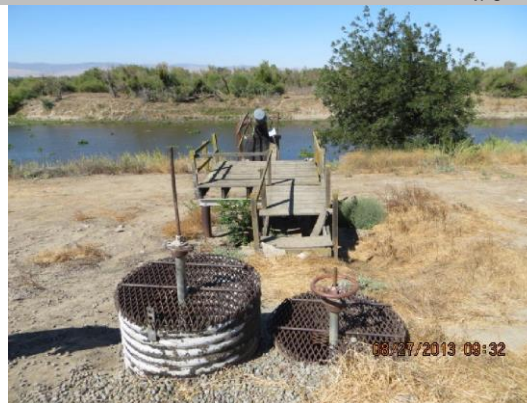
Photo 1 of 3 : UCIP\_SP\_2018\_40792\_31377.jpg

Comment Code					
Inspector Comment					
FS_ID:40792 DS_ID:20533 EP_NO: N/A Repair Type: Non-Urgent Crossing Status: Found UCIP Comments: Pump and slant pipe missing from structure on WS slope. FIELD_STRUCT_DESC: 12-inch concrete encased steel irrigation pipe through the levee, 13 feet below the crown. Slant pump on the waterside (WS) toe. Slide gate in a 36-inch corrugated metal pipe (CMP) riser on the WS shoulder. 6-foot by 6-foot concrete distribution box and filter plant on the landside (LS) toe. 2-inch galvanized iron electrical conduit at the same location. [Additional Reference(s): DWR Levee Log, 2005. USACE San Joaquin O&M Manual 3, December 1968, (HLM 1.24)]. FS Date: 8/27/2013

Slide gate in CMP riser on WS shoulder.

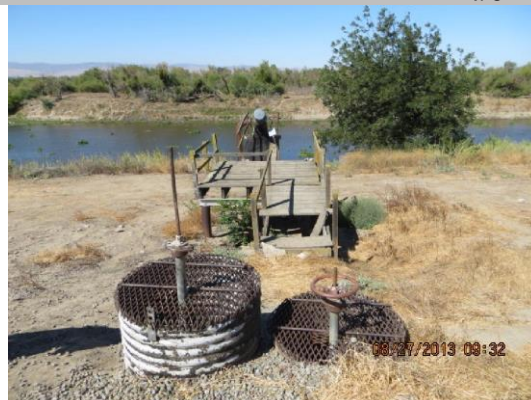
Photo 1 of 3 : UCIP\_SP\_2018\_51638\_38462.jpg

Comment Code					
Inspector Comment					
FS_ID:51638 DS_ID:20524 EP_NO: 3739 Repair Type: Urgent Crossing Status: Found UCIP Comments: 11/16/2016 same as last inspection leak has created sink hole near concrete distribution box located on the LS. Hole in pipe is visible at sink hole. Need to contact owner to address leak on LS. Recommend an internal inspection be completed for the pipe through the levee to determine pipe integrity. (O. Magana - DWR UCIP)08/27/2013 Some leakage at connection between pipe and distro box on LS toe. This may indicate internal failure of pipe. (W. Wylie - DWR UCIP) FIELD_STRUCT_DESC: 16-inch coated steel irrigation pipe through the levee, 10.75 feet below the crown. 2-inch galvanized iron electrical conduit at the same location. Slant pump on the waterside (WS) toe. Slide gate in a 36-inch corrugated metal pipe (CMP) riser on the WS shoulder. 6-foot by 6-foot concrete distribution box and filter plant on the landside (LS) toe. (16-inch pipe authorized under Permit No. 3739, 1961 - Mortensen and Barker). FS Date: 11/16/2016

Slant pump on WS toe. Slide gate in 36-inch CMP riser on WS shoulder.

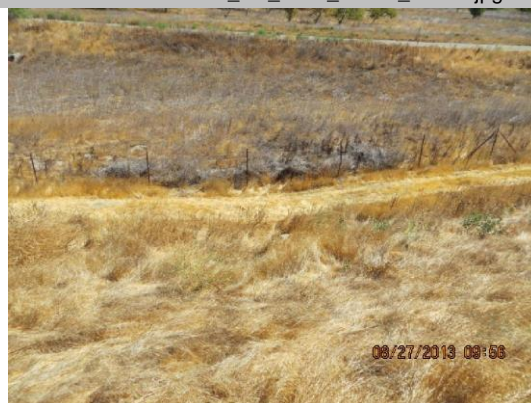
Photo 1 of 3 : UCIP\_SP\_2018\_18748\_31380.jpg

LM Start	1.65	Rating **	A/W	Issue No.	37
LM End	1.65	Issue Type +	Ma	Location *	
Category	Supplemental			GPS Latitude/Longitude	
				Start	End
Item	DWR UCIP LMA Responsibility			37.690072 °	37.690072 °
				-121.269823 °	-121.269823 °
DWR ID					
Comment Code					
Inspector Comment					
FS_ID:18748 DS_ID:20514 EP_NO: N/A Repair Type: No Action Needed Crossing Status: Found UCIP Comments: FIELD_STRUCT_DESC: 30-inch by 30-inch reinforced concrete box drainage culvert through the levee, 15 feet below the crown. Slide gate in a concrete riser on the waterside (WS) shoulder. Concrete U-shaped headwalls on both ends. Flap gate on the WS end. [Additional Reference(s): DWR Levee Log, 2005. USACE San Joaquin O&M Manual 3, December 1968, (HLM 1.65)]. FS Date: 8/27/2013

Concrete headwall on LS toe.

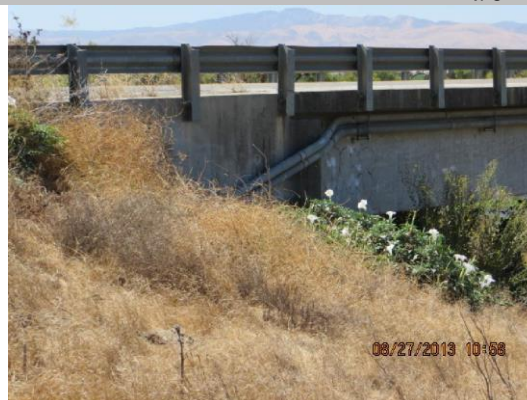
Photo 1 of 1 : UCIP\_SP\_2018\_22085\_37702.jpg

LM Start	3.49	Rating **	M	Issue No.	40
LM End	3.49	Issue Type +	En	Location *	
Category	Supplemental			GPS Latitude/Longitude	
				Start	End
Item	DWR UCIP Field Study			37.676276 °	37.676276 °
				-121.264104 °	-121.264104 °
DWR ID					
Comment Code					
Inspector Comment					
FS_ID:22085 DS_ID:24059 EP_NO: N/A Repair Type: Non-Urgent Crossing Status: Found UCIP Comments: Unable to identify purpose or permit for this crossing. FIELD_STRUCT_DESC: 1 of 2: 4-inch galvanized iron conduit of an unknown purpose through the levee, at an unknown depth. Visible on downstream side of the bridge. 3.5-foot by 6-foot steel vault on crown. FS Date: 8/27/2013

Upper conduit visible on DS side of bridge.

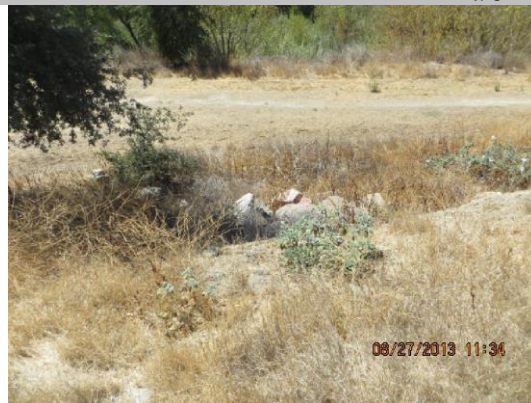
Photo 1 of 2 : UCIP\_SP\_2018\_19046\_31849.jpg

Concrete rubble on WS slope possible indicator of abandoned pipe location.

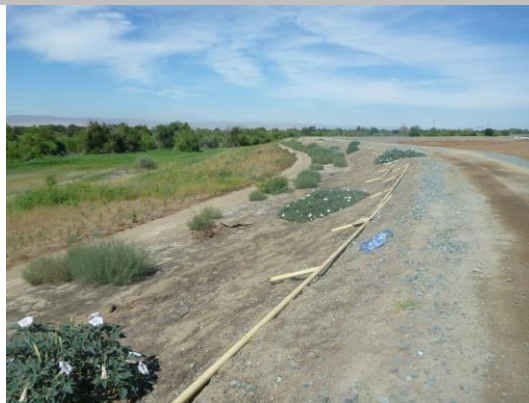
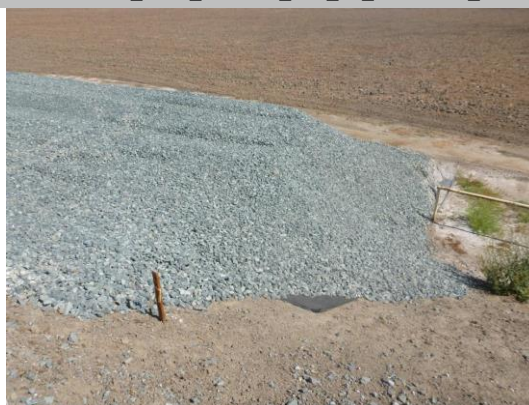
LM Start	3.92	Rating **	A/W	Issue No.	24
LM End	4.03	Issue Type +	Ob	Location *	
Category	Supplemental			GPS Latitude/Longitude	
				Start	End
Item	2017 Storm Damage			37.673190 °	37.672180 °
				-121.258140 °	-121.256490 °
DWR ID	DWR_RD2064_01_f_2017_24				
Comment Code					
Inspector Comment					
Levee Evaluation Comments					
Description:The damaged area is due to extensive seepage occurring from high river flows, especially when the water level is above 25.0' at the Vernalis Gauge. The damage is from long term saturated soil within the levee structure beyond the landside toe. This area is an extension of a seepage berm placed on an emergency work order in February 2017.					
Site ID No:581					
Site Designation:LMA-487					
Repair Type: Seepage					
Rating:Area of Concern					
Field Date:8/14/2017					
Notes:

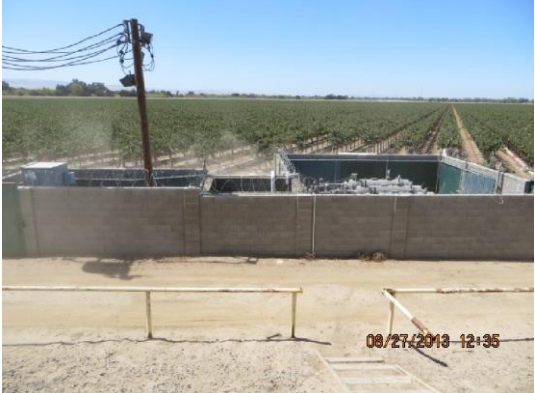
Photo 1 of 2 : UCIP\_SP\_2018\_19063\_31861.jpg

Concrete distribution box remains in center of structure on LS toe.

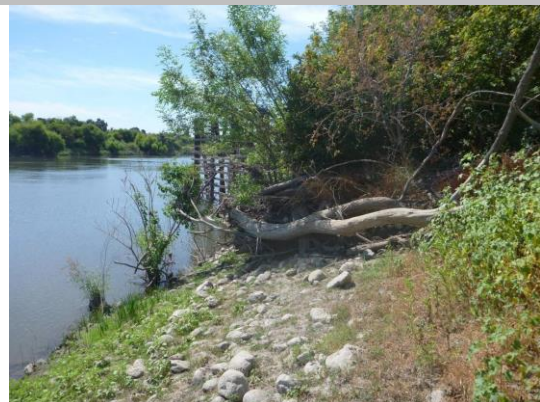
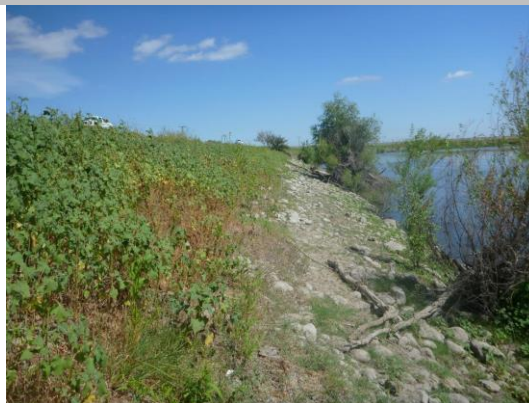
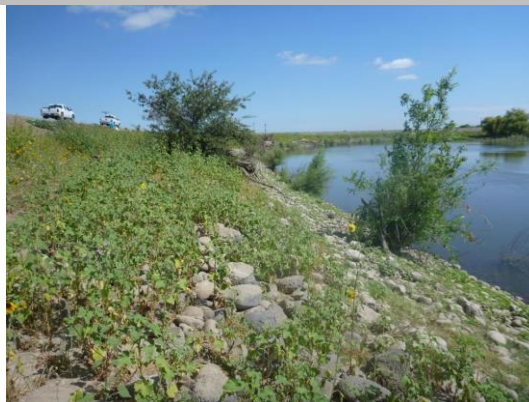
LM Start	4.82	Rating **	A/W	Issue No.	26
LM End	4.85	Issue Type +	Ma	Location *	
Category	Supplemental			GPS Latitude/Longitude	
				Start	End
Item	2017 Storm Damage			37.671730 °	37.672140 °
				-121.246820 °	-121.246800 °
DWR ID	DWR_RD2064_01_f_2017_26				
Comment Code					
Inspector Comment					
Levee Evaluation Comments					
Description:Erosion from high water flows caused erosion scarps from 12" to 24" in height. The area of damage is approximately 600 feet in length.					
Site ID No:583					
Site Designation:LMA-489					
Repair Type: Erosion					
Rating:Area of Concern					
Field Date:8/14/2017					
Notes: Minor toe erosion

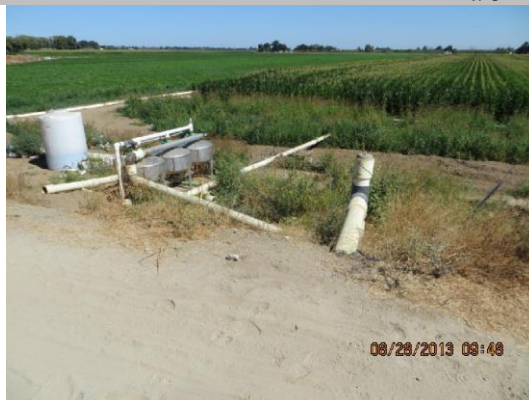
Photo 1 of 3 : UCIP\_SP\_2018\_44653\_37715.jpg

Pipe, vent, and filter plant on LS shoulder and LS toe.

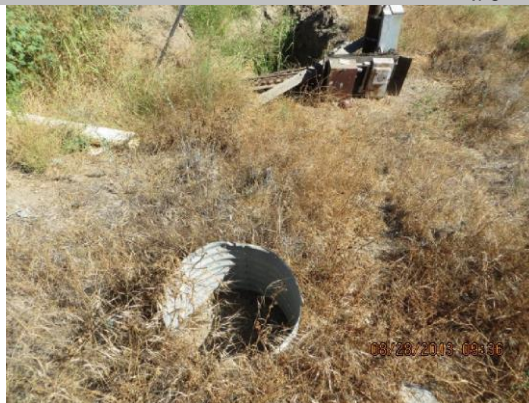
Photo 1 of 3 : UCIP\_SP\_2018\_51385\_31892.jpg

Siphon breaker in 24-inch CMP riser on LS shoulder.

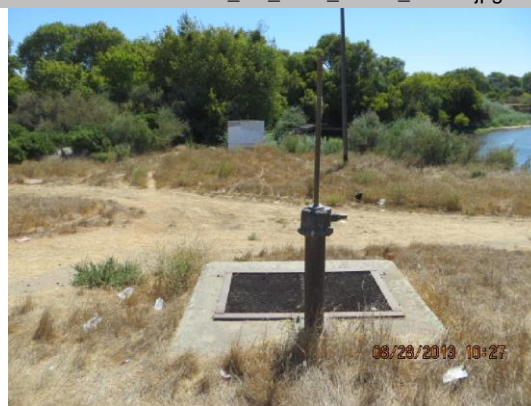
Photo 1 of 3 : UCIP\_SP\_2018\_19086\_31954.jpg

Gate valve on WS shoulder. Pump next to concrete riser in background.

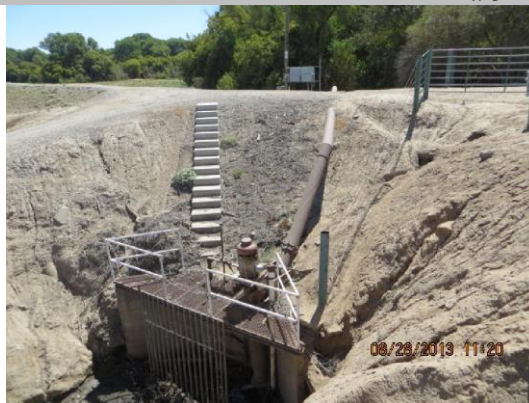
Photo 1 of 2 : UCIP\_SP\_2018\_22107\_37736.jpg

Pump for pipe on concrete headwall at LS toe.

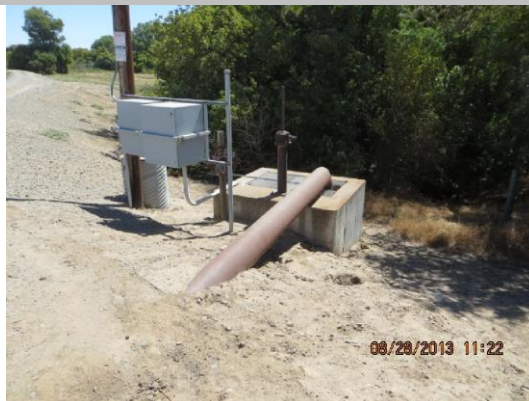
Photo 2 of 2 : UCIP\_SP\_2018\_22107\_37735.jpg

Pipe discharges into concrete riser on WS slope.

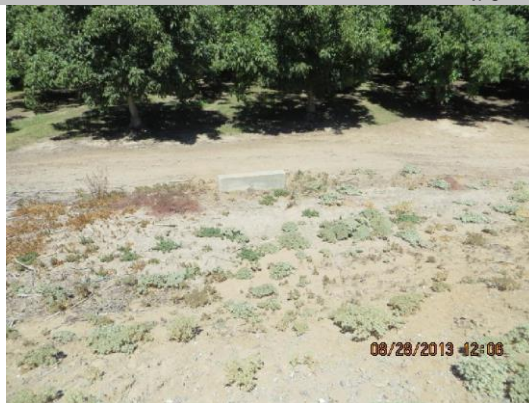
Photo 1 of 3 : UCIP\_SP\_2018\_19117\_32069.jpg

LM Start	4.41	Rating **	A/W	Issue No.	30
LM End	4.41	Issue Type +	Ma	Location *	
Category	Supplemental			GPS Latitude/Longitude	
				Start	End
Item	DWR UCIP LMA Responsibility			37.696386 °	37.696386 °
				-121.202963 °	-121.202963 °
DWR ID					
Comment Code					
Inspector Comment					
FS_ID:19117 DS_ID:20549 EP_NO: N/A Repair Type: No Action Needed Crossing Status: Found UCIP Comments: FIELD_STRUCT_DESC: 30-inch drainage pipe of an unknown material through the levee, 10.5 feet below the crown. Concrete U-shaped headwalls on both ends. Flap gate on the waterside (WS) end. Two corrugated metal cutoff walls. [Additional Reference(s): DWR Levee Log, 2005. USACE San Joaquin O&M Manual 3, December 1968, (HLM 4.37)]. FS Date: 8/28/2013

Headwall on LS toe.

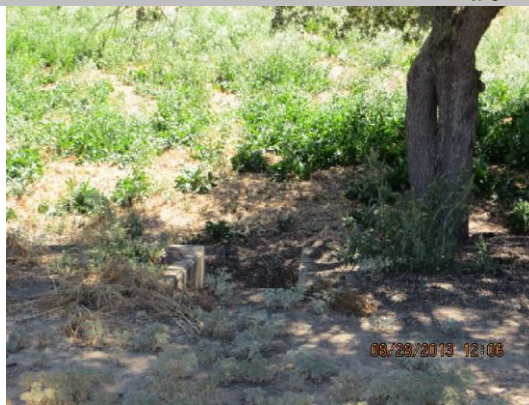
Photo 2 of 3 : UCIP\_SP\_2018\_19117\_32068.jpg

Headwall on WS toe.

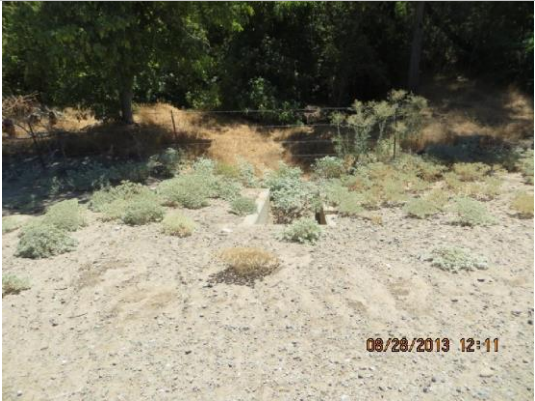
Photo 1 of 3 : UCIP\_SP\_2018\_22793\_38842.jpg

Concrete headwall on WS toe.

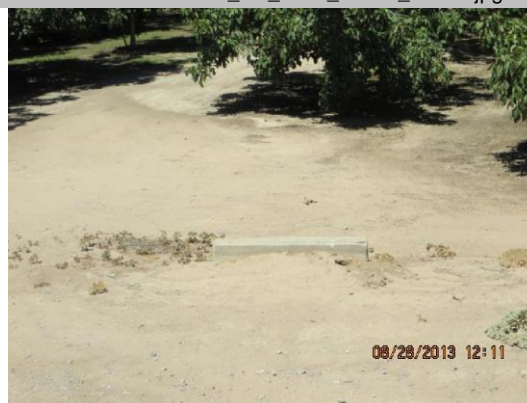
Photo 2 of 3 : UCIP\_SP\_2018\_22793\_38841.jpg

Concrete headwall on LS toe.

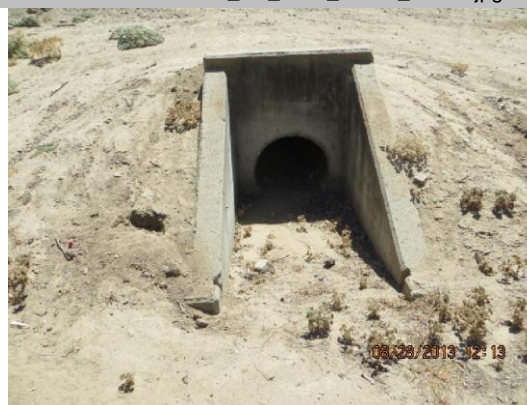
Photo 3 of 3 : UCIP\_SP\_2018\_22793\_38844.jpg

Concrete headwall on LS toe.

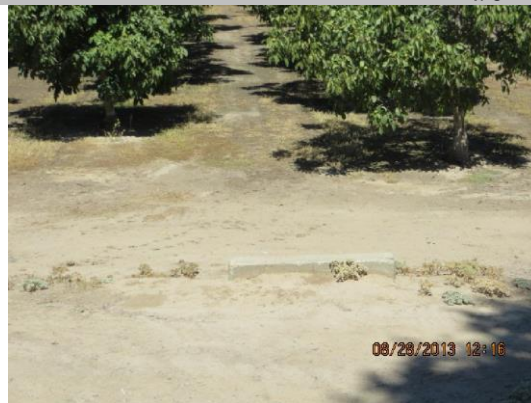
Photo 1 of 3 : UCIP\_SP\_2018\_19120\_32079.jpg

LM Start	4.64	Rating **	A/W	Issue No.	32
LM End	4.64	Issue Type +	Ma	Location *	
Category	Supplemental			GPS Latitude/Longitude	
				Start	End
Item	DWR UCIP LMA Responsibility			37.697101 °	37.697101 °
				-121.199048 °	-121.199048 °
DWR ID					
Comment Code					
Inspector Comment					
FS_ID:19120 DS_ID:20551 EP_NO: N/A Repair Type: No Action Needed Crossing Status: Found UCIP Comments: FIELD_STRUCT_DESC: 30-inch corrugated metal drainage pipe through the levee, 10 feet below the crown. Concrete U-shaped headwalls on both ends. Flap gate on the waterside (WS) end. Two corrugated metal cutoff walls. Grouted spillway on the WS. Spillway damaged due to uprooted tree. [Additional Reference(s): DWR Levee Log, 2005. USACE San Joaquin O&M Manual 3, December 1968, (HLM 4.59)]. FS Date: 8/28/2013

Concrete headwall on LS toe.

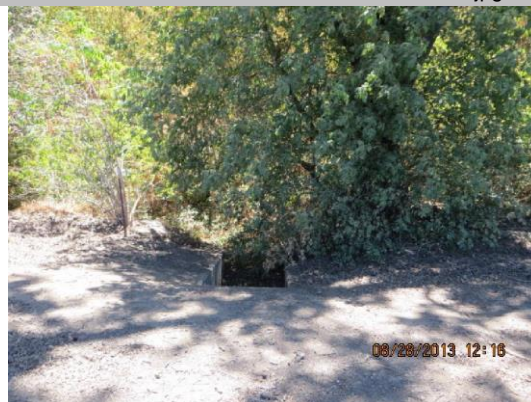
Photo 2 of 3 : UCIP\_SP\_2018\_19120\_32078.jpg

Concrete headwall on WS toe.

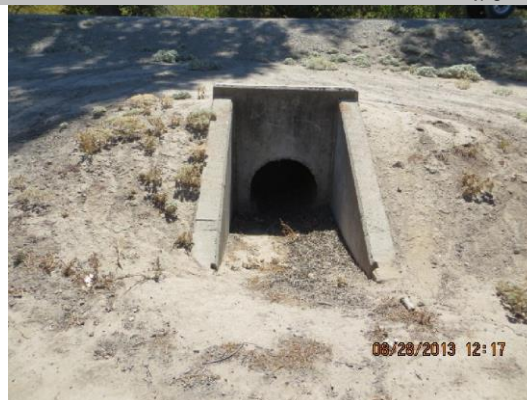
Photo 3 of 3 : UCIP\_SP\_2018\_19120\_32077.jpg

Concrete headwall on LS toe.

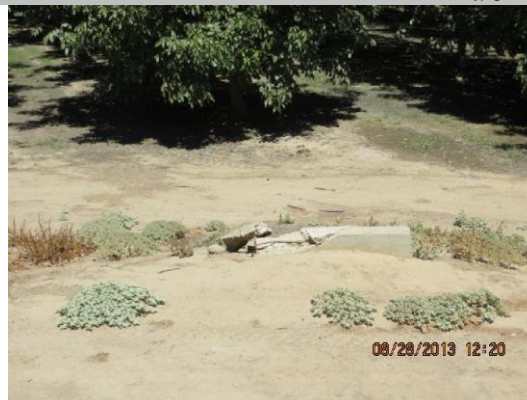
Photo 1 of 3 : UCIP\_SP\_2018\_19122\_32083.jpg

LM Start	4.78	Rating **	A/W	Issue No.	33
LM End	4.78	Issue Type +	Ma	Location *	
Category	Supplemental			GPS Latitude/Longitude	
				Start	End
Item	DWR UCIP LMA Responsibility			37.696888 °	37.696888 °
				-121.196511 °	-121.196511 °
DWR ID					
Comment Code					
Inspector Comment					
FS_ID:19122 DS_ID:20552 EP_NO: N/A Repair Type: No Action Needed Crossing Status: Found UCIP Comments: FIELD_STRUCT_DESC: 30-inch corrugated metal drainage pipe through the levee, 8.5 feet below the crown. Concrete U-shaped headwalls on both ends. Flap gate on the waterside (WS) end. Two corrugated metal cutoff walls. Grouted spillway on the WS. [Additional Reference(s): DWR Levee Log, 2005. USACE San Joaquin O&M Manual 3, December 1968, (HLM 4.73)]. FS Date: 8/28/2013

Concrete headwall on LS toe.

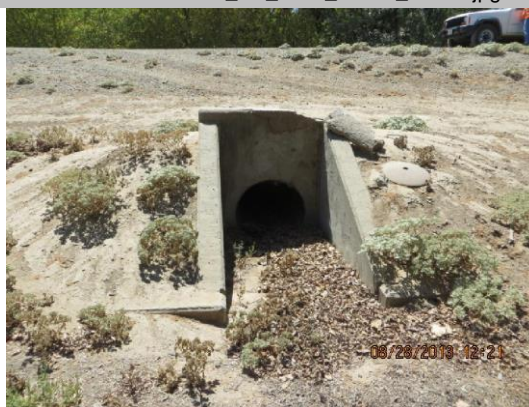
Photo 3 of 3 : UCIP\_SP\_2018\_19122\_32081.jpg

Concrete headwall on LS toe.

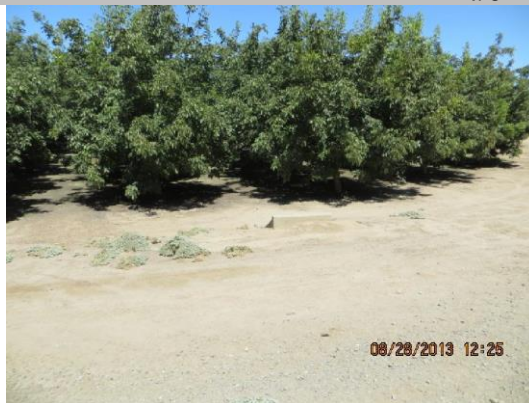
Photo 1 of 3 : UCIP\_SP\_2018\_19143\_32122.jpg

LM Start	4.92	Rating **	A/W	Issue No.	36
LM End	4.92	Issue Type +	Ma	Location *	
Category	Supplemental			GPS Latitude/Longitude	
				Start	End
Item	DWR UCIP LMA Responsibility			37.696146 °	37.696146 °
				-121.194093 °	-121.194093 °
DWR ID					
Comment Code					
Inspector Comment					
FS_ID:19143 DS_ID:20553 EP_NO: N/A Repair Type: No Action Needed Crossing Status: Found UCIP Comments: FIELD_STRUCT_DESC: 30-inch corrugated metal drainage pipe through the levee, 8 feet below the crown. Concrete U-shaped headwalls on both ends. Flap gate on the waterside (WS) end. Two corrugated metal cutoff walls. Grouted spillway on the WS. [Additional Reference(s): DWR Levee Log, 2005. USACE San Joaquin O&M Manual 3, December 1968, (HLM 4.88)]. FS Date: 8/28/2013

Concrete headwall on LS toe.

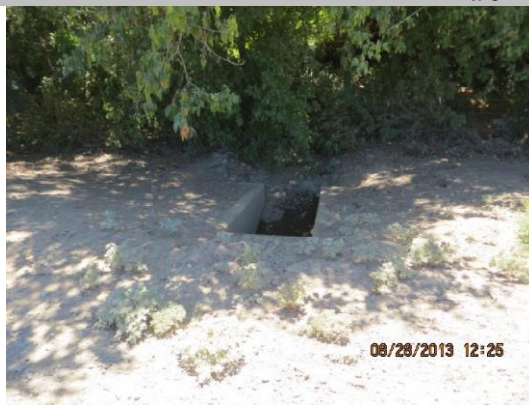
Photo 2 of 3 : UCIP\_SP\_2018\_19143\_32121.jpg

Concrete headwall on WS toe.

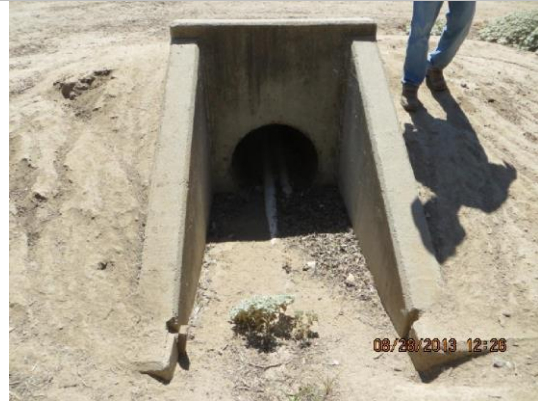
Photo 3 of 3 : UCIP\_SP\_2018\_19143\_32120.jpg

Concrete headwall on LS toe.

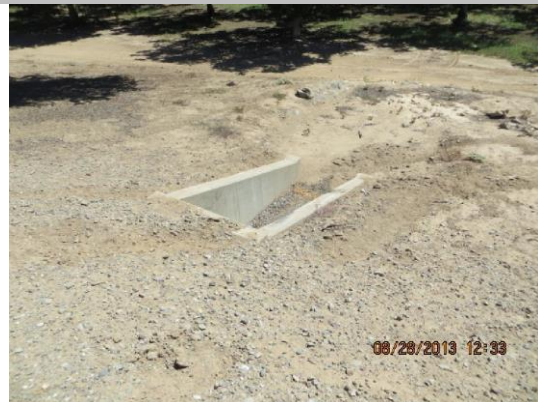
Photo 1 of 3 : UCIP\_SP\_2018\_22794\_38851.jpg

LM Start	5.10	Rating **	A/W	Issue No.	37
LM End	5.10	Issue Type +	Ma	Location *	
Category	Supplemental			GPS Latitude/Longitude	
				Start	End
Item	DWR UCIP LMA Responsibility			37.697483 °	37.697483 °
				-121.191332 °	-121.191332 °
DWR ID					
Comment Code					
Inspector Comment					
FS_ID:22794 DS_ID:20554 EP_NO: N/A Repair Type: No Action Needed Crossing Status: Found UCIP Comments: FIELD_STRUCT_DESC: 30-inch corrugated metal drainage pipe through the levee, 8 feet below the crown. Concrete U-shaped headwalls on both ends. Flap gate on the waterside (WS) end. Two corrugated metal cutoff walls. Grouted spillway on the WS. [Additional Reference(s): DWR Levee Log, 2005. USACE San Joaquin O&M Manual 3, December 1968, (HLM 5.05)]. FS Date: 8/28/2013

Concrete U shaped headwall on WS toe.

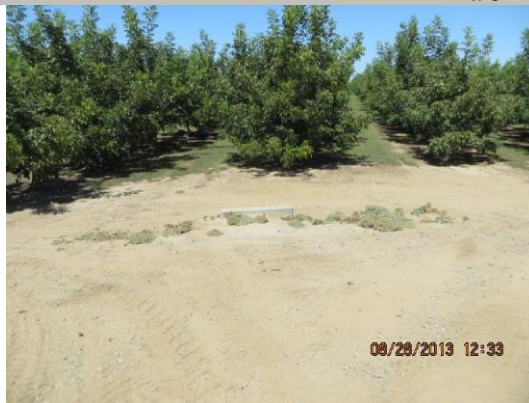
Photo 2 of 3 : UCIP\_SP\_2018\_22794\_38850.jpg

Concrete headwall on LS toe.

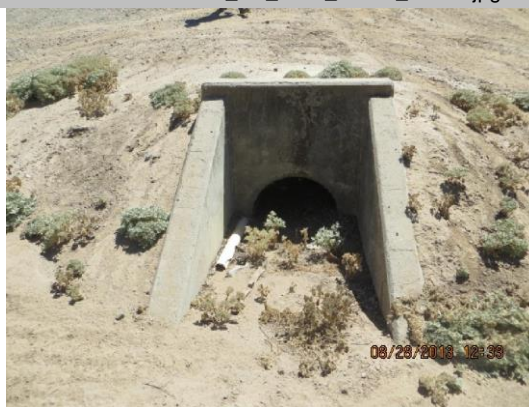
Photo 3 of 3 : UCIP\_SP\_2018\_22794\_38853.jpg

Concrete headwall on LS toe.

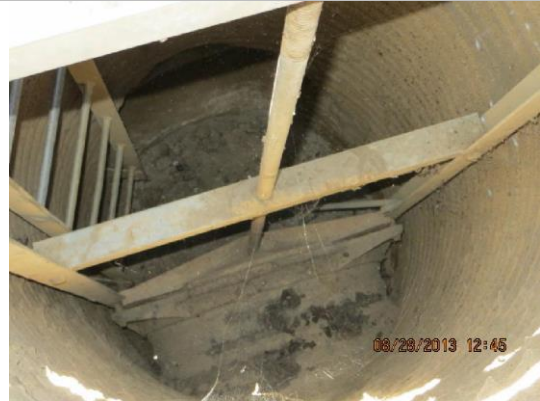
Photo 2 of 2 : UCIP\_SP\_2018\_19145\_32125.jpg

Pipe in CMP riser on WS slope.
